Bridge over Uhamba river

CASE STUDY | BRIDGES

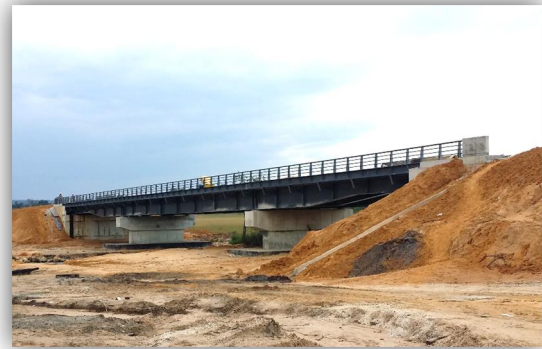
Figure 1 – Bridge over Uhamba river.

The bridge over Uhamba river is located in Caungula, North Lunda, Angola, at 800km of the capital Luanda (Figure 1). It was designed, fabricated and erected by VESAM in 2013.

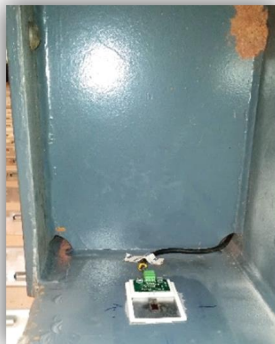
Figure 6 – Installation of strain sensor on the bottom flange of the main girder.

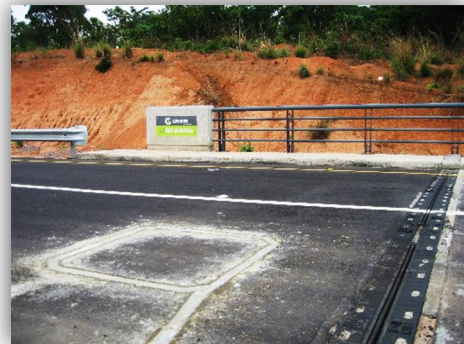
Figure 7 – Installation of inductive loop on the pavement for traffic detection.
