Bridge over Kusso river

CASE STUDY | BRIDGES

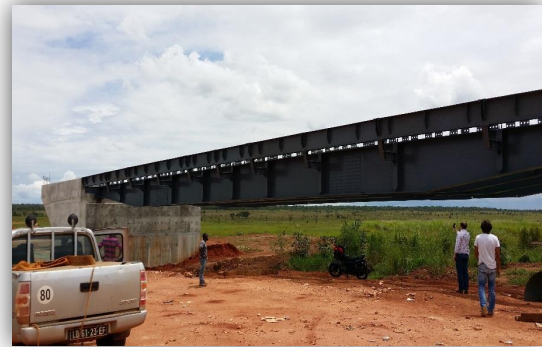
Figure 1 – Bridge over Kusso river.

The bridge over Kusso river is located in Bailundo, Huambo, Angola, at 600km of the capital Luanda (Figure 1). It was designed, fabricated and erected by VESAM in 2014.

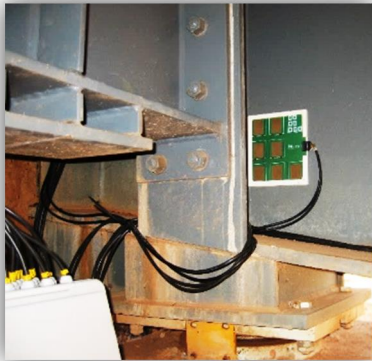
Figure 5 – Installation of the corrosion sensor at the North abutment.

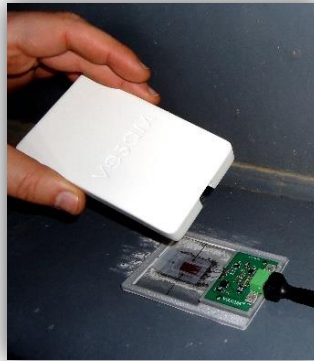
Figure 6 – Installation of strain sensor on the bottom flange of the main girder at mid-span.

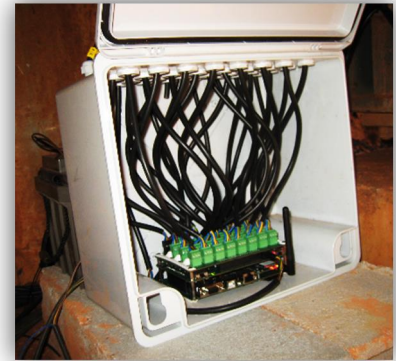
Figure 7 – Installation of the data acquisition system at the North abutment.

The data acquisition unit (SIGMA) is located in the north abutment and connected by wire to all sensors (Figure 7). It is powered by a solar panel combined with a 12V battery. All equipment is provided by VESAM.
