Várzeas Bridge

CASE STUDY | BRIDGES

The Várzeas Bridge is located in Mealhada, a small town at 20km to the north of Coimbra, the third major city of Portugal (Figure 1). The bridge was designed, fabricated and erected by VESAM in 2008.

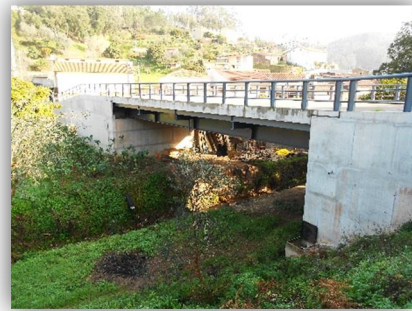
Figure 1 – Várzeas Bridge.

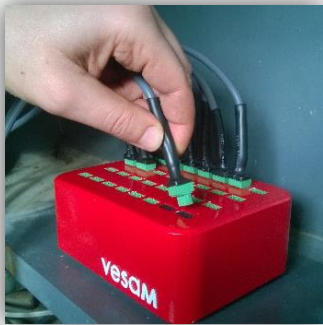
Figure 4 – Installation of data acquisition system.

The data acquisition unit (SIGMA) is located in the south abutment and connected by wire to all sensors. It is powered by a solar panel combined with a 12V battery. All equipment is provided by VESAM.

The adopted communications protocol for data transfer between the SHM system and the VESAM servers is by GPRS/GSM. The data are collected by the data acquisition unit and sent on a periodically basis to the VESAM server.

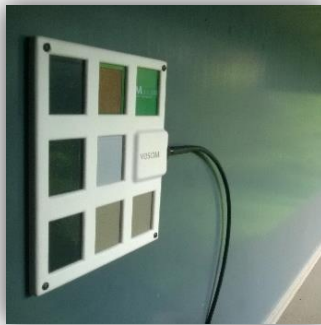
Figure 5 – Installation of the corrosion sensor in the web of the main girder.

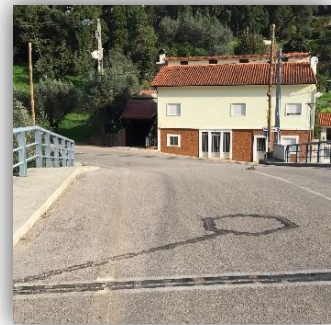
Figure 6 – Installation of inductive loop on the pavement for traffic detection.

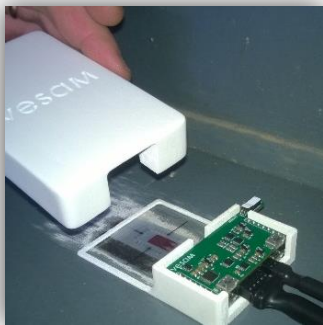
Figure 7 – Installation of OneSensor (strain gauge, accelerometer, temperature and relative humidity sensors all-in-one).

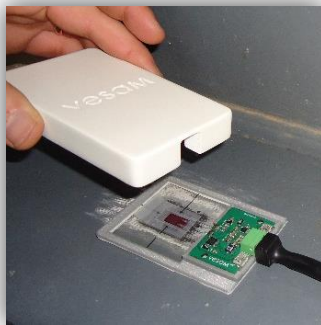
Figure 8 – Installation of strain gauge on the bottom flange of the main girder.

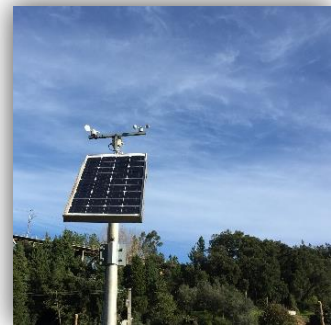
Figure 9 – Weather station with energy harvesting system (solar power).
